The subject property is an approximately 44 year old, wood frame detached house on crawlspace and slab .Refer to the body of the report for improvement recommendations.

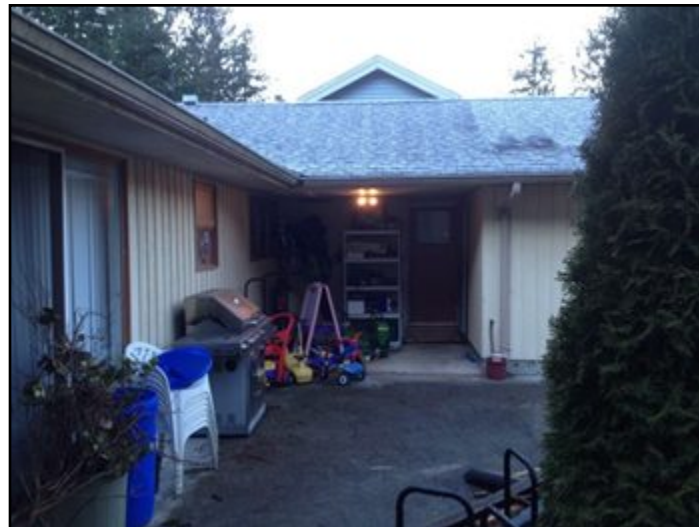
*Ice on roof at time of inspection*

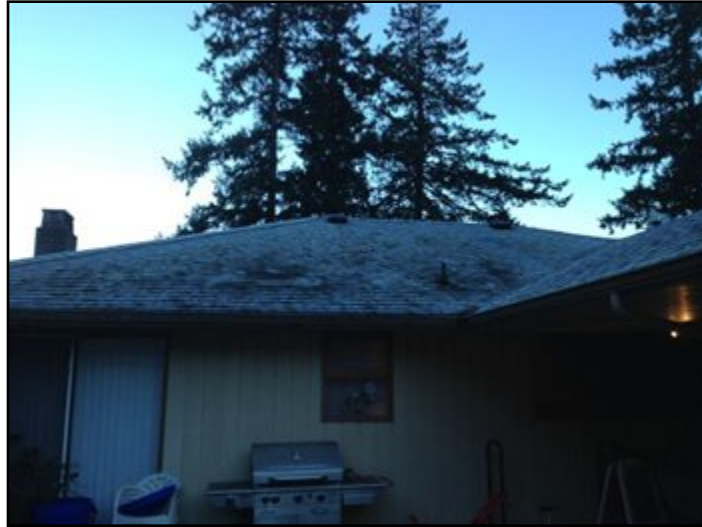
**Condition:** • Regular maintenance and inspections by a certified roofing contractor recommended  
Some moss noted on roof. Recommend treatment. Obtain any leak history from vendors.

*Moss noted on some areas of roof*

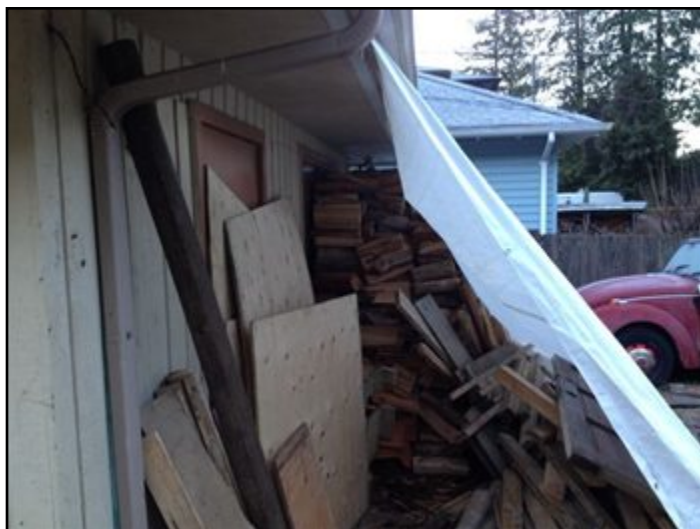
*Wood storage against back wall noted*

**Condition:** • Wood storage against back wall . No access to wall. Recommend removing wood and inspecting for any rot damage.

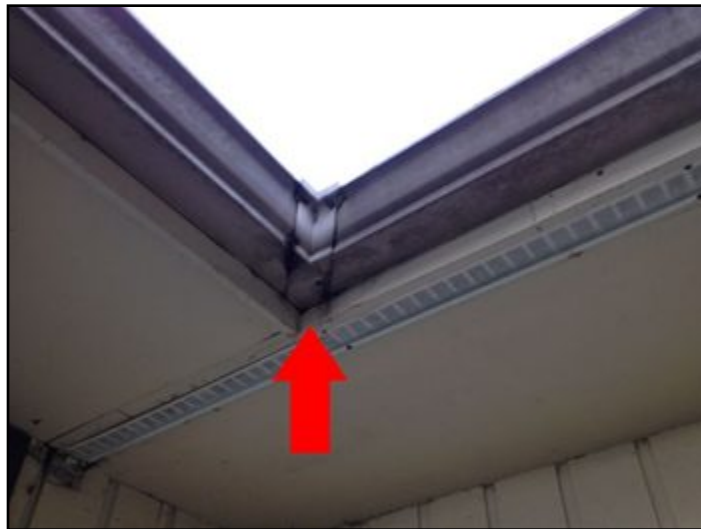
Various leaks noted in gutter corners.

*Various leaks noted*

**Task:** Repair

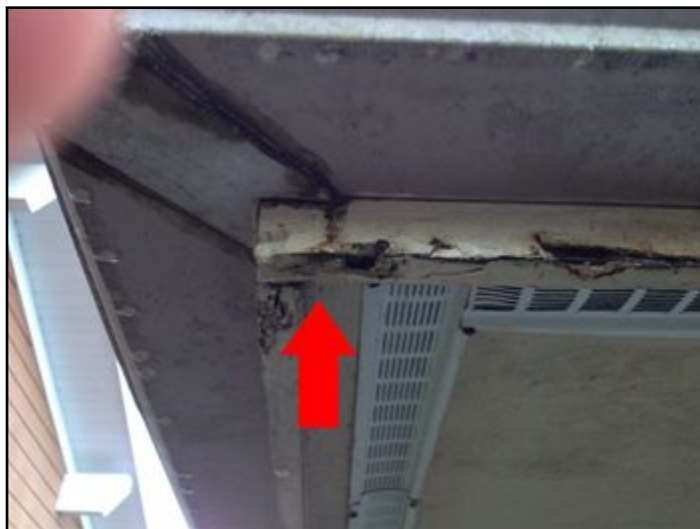
Some rot noted in facial board. Possible gutter leakage.

Face board rot noted

**Task:** Further evaluate & repair

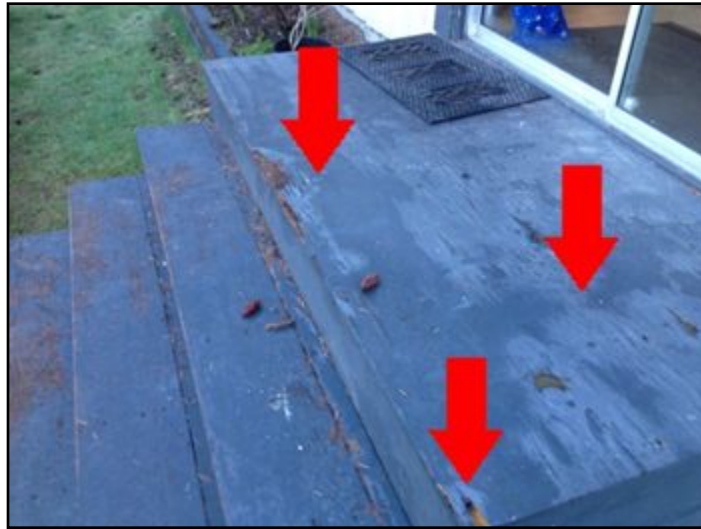
**Condition:** • Some rot noted in front steps. No protection from water damage.

*Rot noted. No weather protection.*

**Task:** Repair / Replace

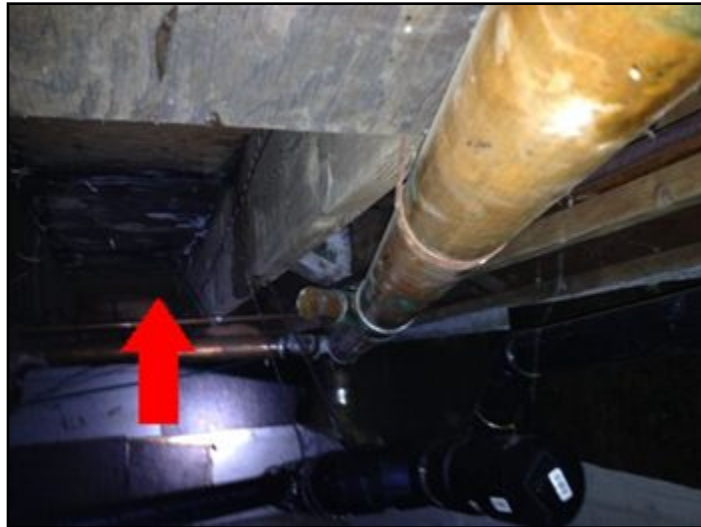
**Condition:** • Water staining and rot noted under bathroom in crawl space .

*Water damage and rot noted*

**Task:** Further evaluate & repair

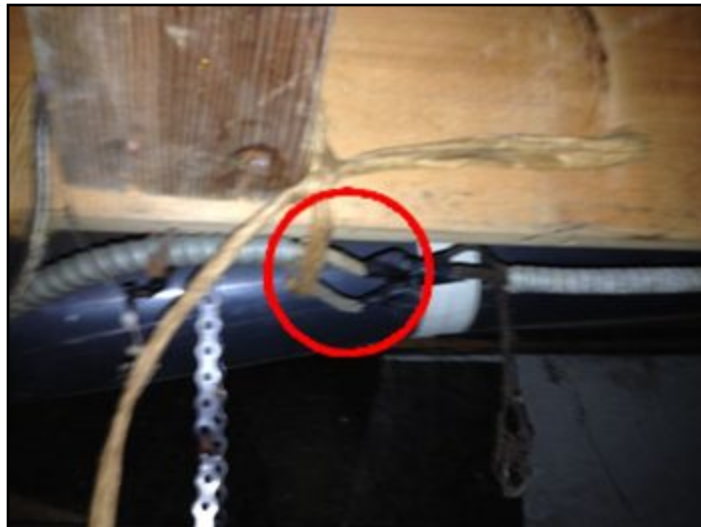
*Exposed wiring connection*

**Task:** Further evaluate & repair

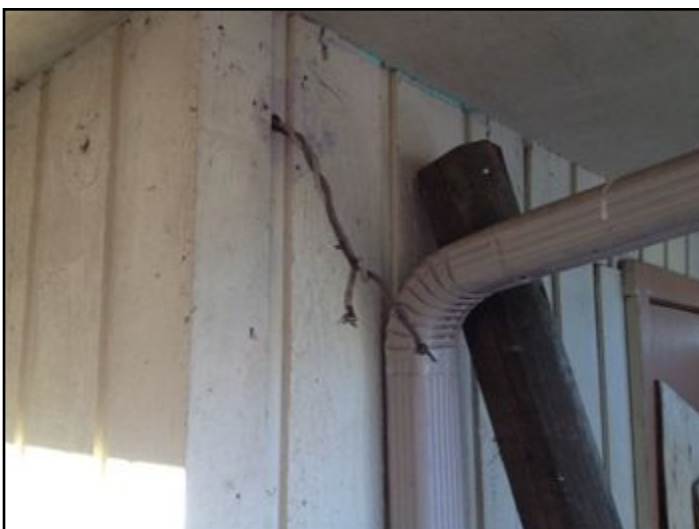
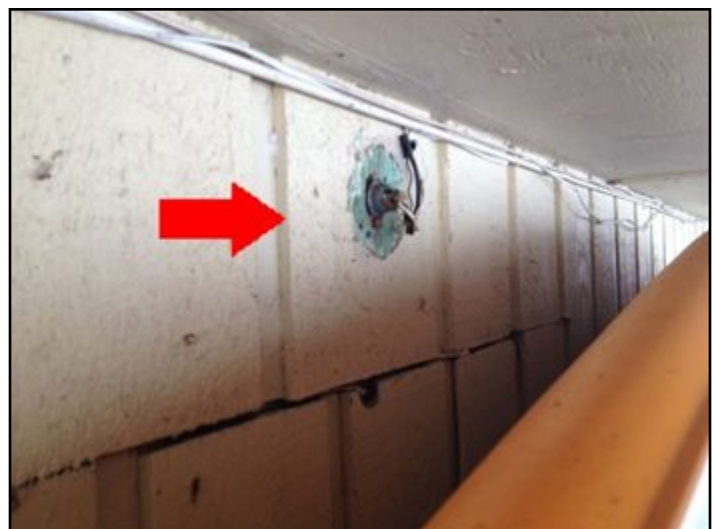
Exposed live wires noted

*Live wires noted*

**Task:** Improve

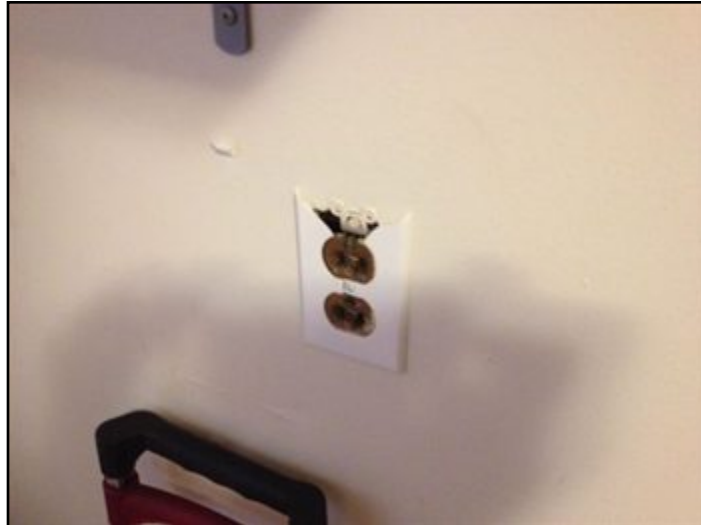
*Damaged cover plate noted*

**Task:** Replace

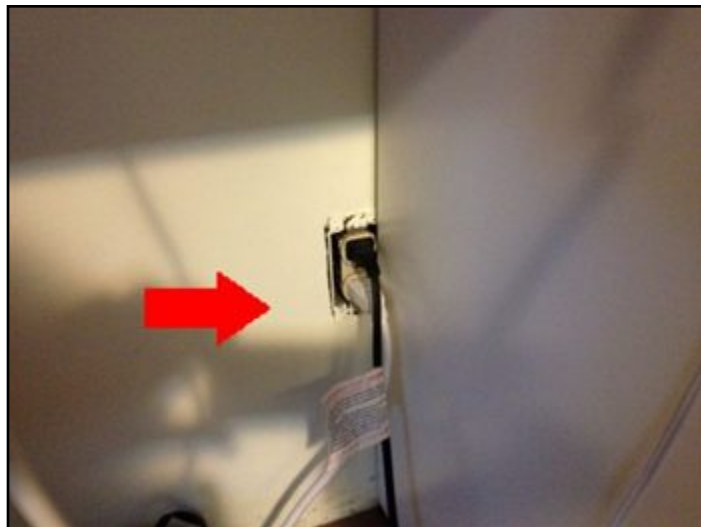
*No cover plate noted*

**Task:** Provide

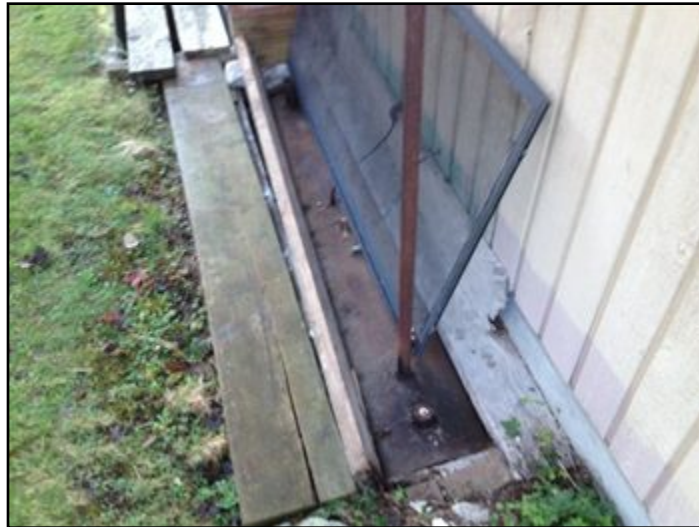
**Condition:** • Oil tank noted on outside of house . Recommend further evaluation for any leakage and condition of oil tank

*Oil tank*

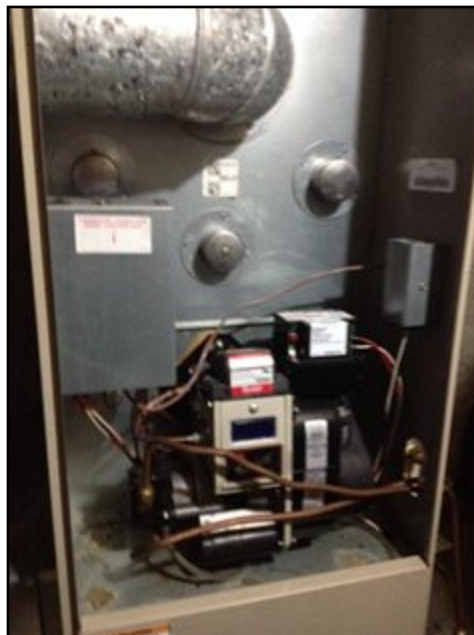
**Condition:** • Oil furnace has not been used in over two years. Further evaluation and servicing is needed

*Oil furnace*

**Task:** Further evaluate & repair

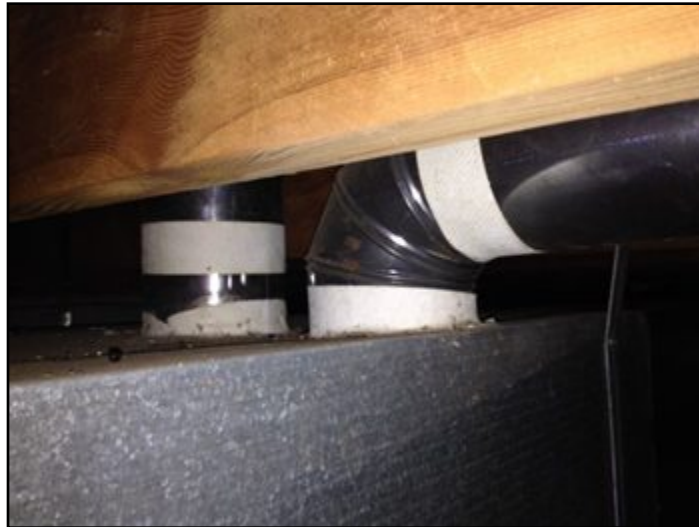
**Condition:** • Duct tape for heating ducts may contain asbestos . Testing and improvements recommended if this is a concern for you.

*Tape may contain asbestos*

**Task:** Improve

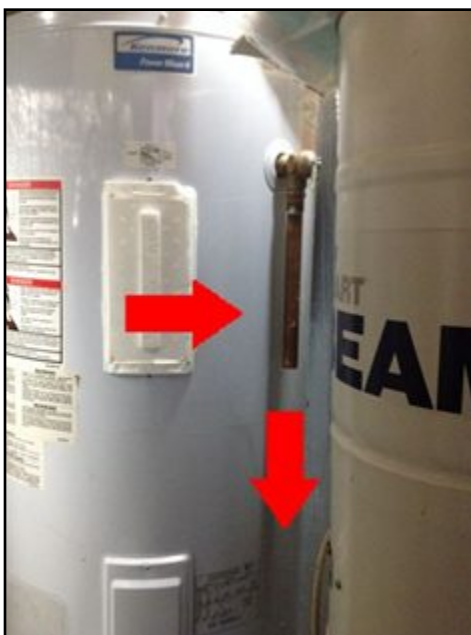
*Discharge tube to short*

**Task:** Replace

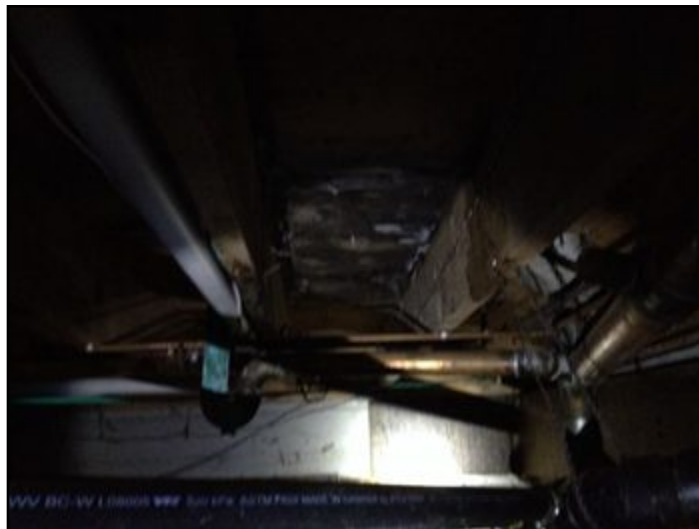
Some rust noted on piping under back bathroom in crawl/ space

*Rust noted on trap*

**Task:** Further evaluate & repair

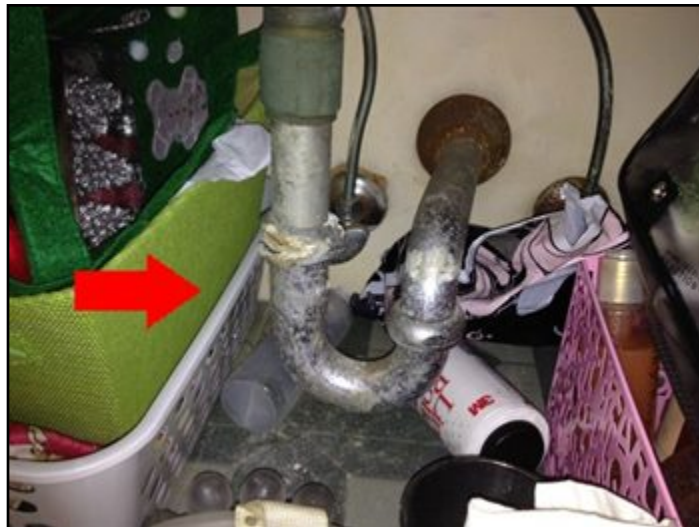
Recommend replacing old rusty trap under sink in main bathroom

*Rusty trap noted*

**Task:** Replace

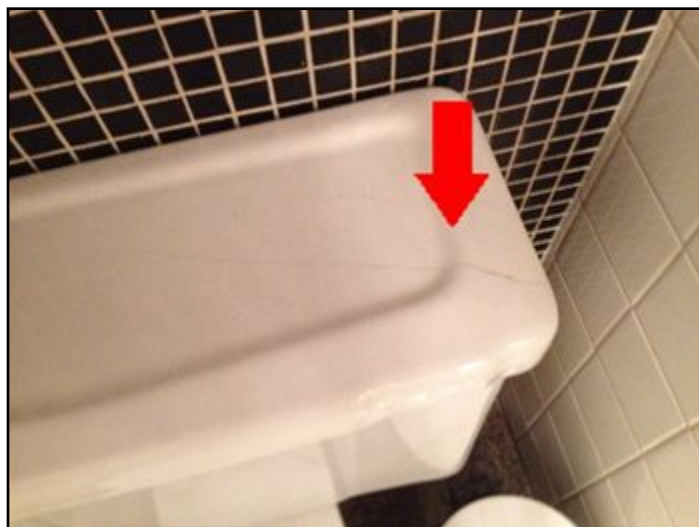
*Cracked lid noted*

**Task:** Replace

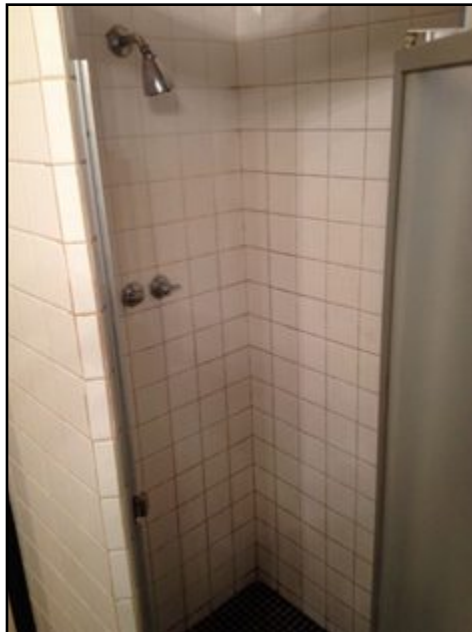
*Shower stall*

**Condition:** • Moisture meter indicated water infiltration behind tiles. Probable hidden damage to substrate (likely gypsum wallboard) and possible damage to wood framing members. Replacement of shower stall is recommended. Water damage noted under bathroom floor in crawl- space all so .

**Task:** Further evaluate & repair

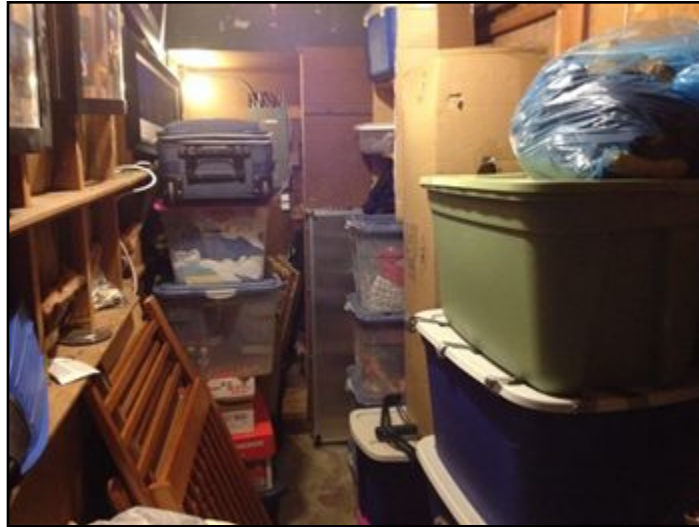
*Excessive storage in some areas*

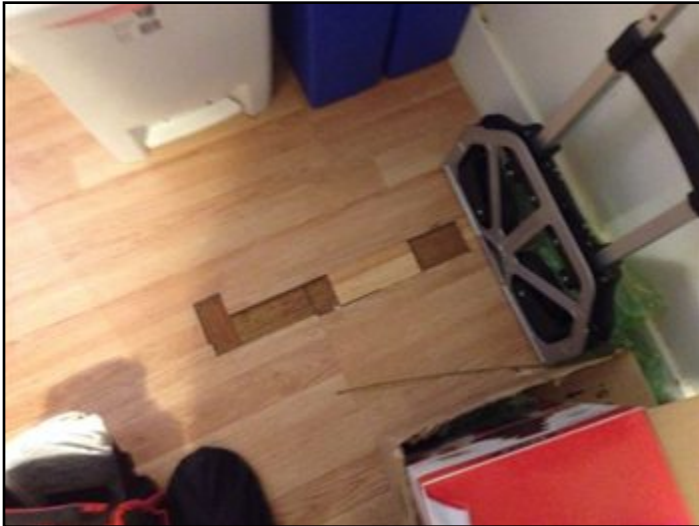
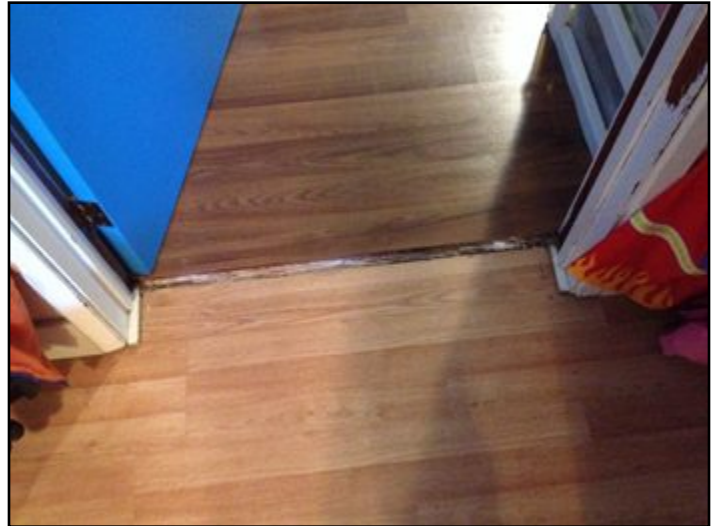
**Condition:** • Some unfinished floor areas noted

*Missing flooring*

*Unfinished flooring*

**Task:** Repair

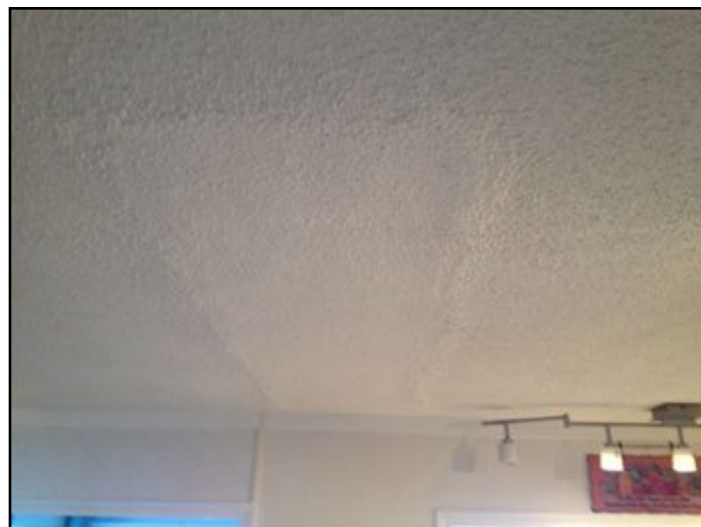
*Ceiling patch noted*

**Task:** Further evaluate

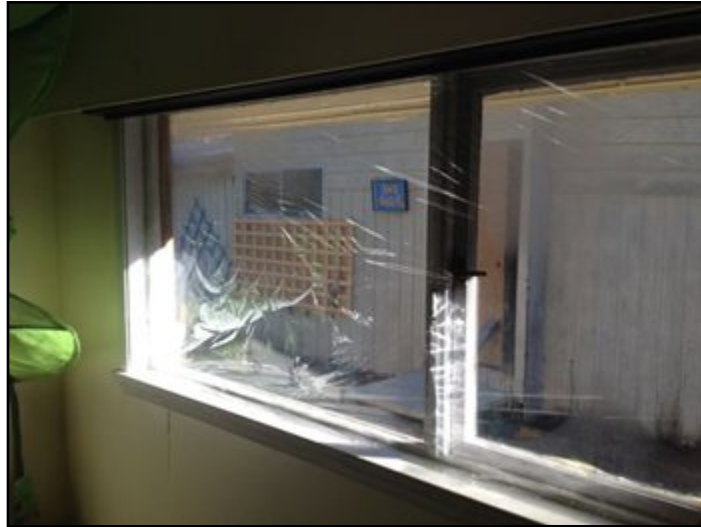
**Condition:** • Most windows covered with plastic film. Openers not tested

*Plastic covering windows*

**Task:** Further evaluate

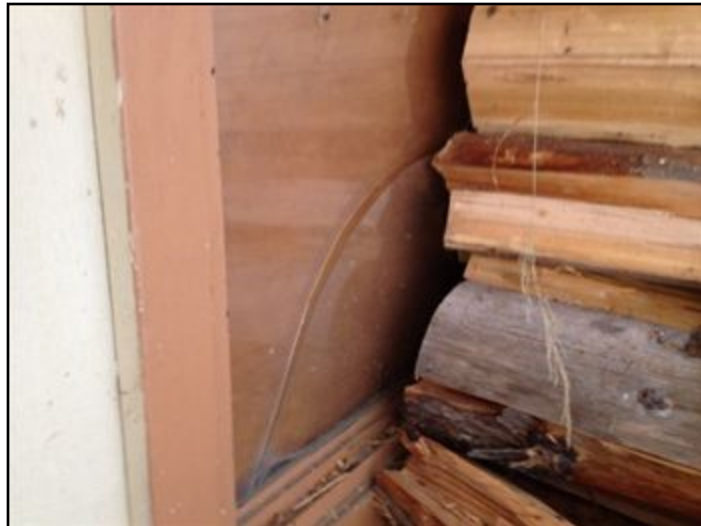
*Broken window noted*

**Task:** Replace

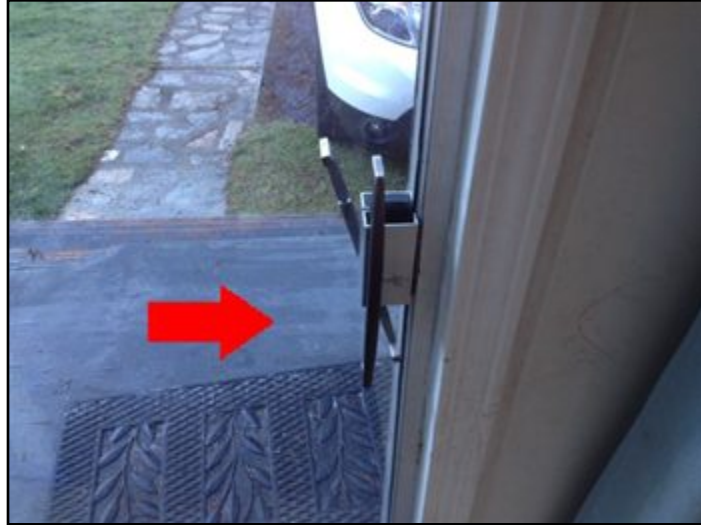
*Door hardware damaged*

**Task:** Repair

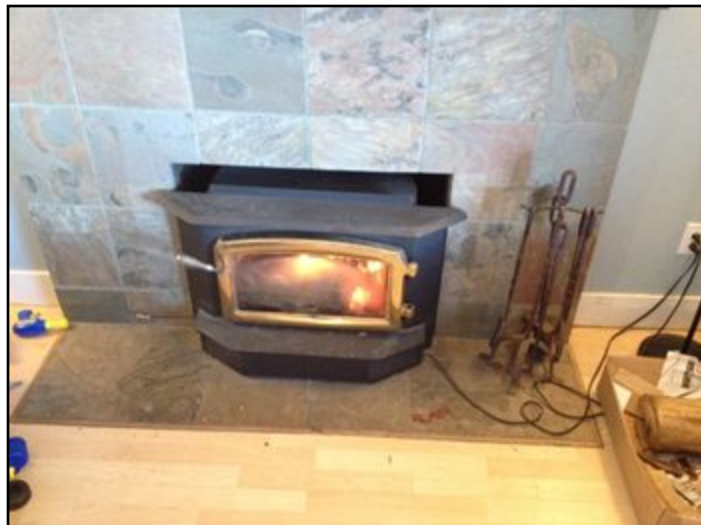
**Condition:** • Wood stove or wood insert, flue and chimney should be inspected and swept as needed by a WETT certified technician and any recommended repairs completed before the unit is used. (WETT - Wood Energy Technology Transfer Inc. is a non-profit training and education association.) See [www.wettinc.ca](http://www.wettinc.ca).

*Wood stove noted*

**Task:** Further evaluate
